**IN THE UNITED STATES DISTRICT
COURT FOR THE NORTHERN DISTRICT
OF ILLINOIS EASTERN DIVISION**

**DEFENDANTS NICHOLAS GONRING AND KELSEY
GONRING'S
LR 56.1 STATEMENT OF ADDITIONAL UNDISPUTED MATERIAL
FACTS**

Engineering Systems Inc. (ESI) was retained by Erie Insurance Group in regard to an issue with water infiltration occurring in a multi-family residential structure. The structure, managed by the 2726 W. Cortez Street Condo Association, was located at 2726 W. Cortez Street in Chicago, Illinois. ESI was retained to determine the cause of water infiltration occurring in Unit 3, which was owned by John Gorr.

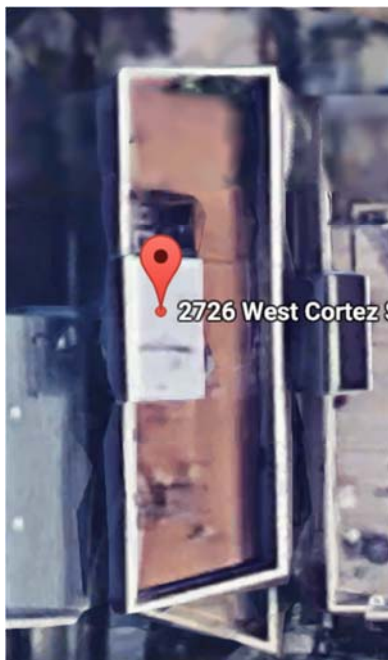
ESI made a site inspection to the structure on October 19, 2017. The subject structure was a three-story condominium with a masonry exterior and a flat roof. Figure 1 provides a satellite view of the structure taken from Google Maps. Figure 2 provides an elevation view of the front of the structure taken at the time of the site inspection. It is estimated that the structure was constructed between 10 and 15 years ago.

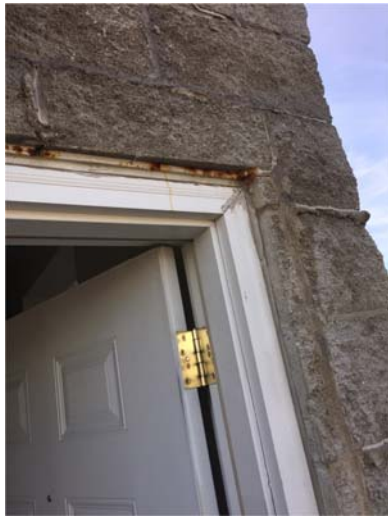
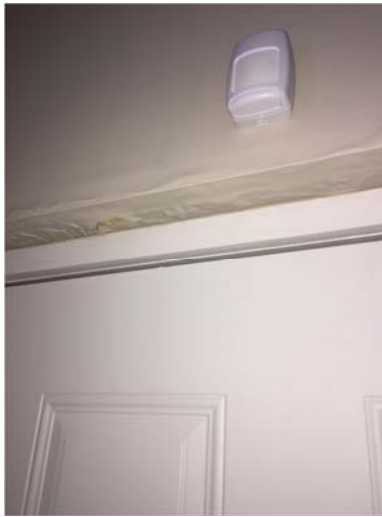
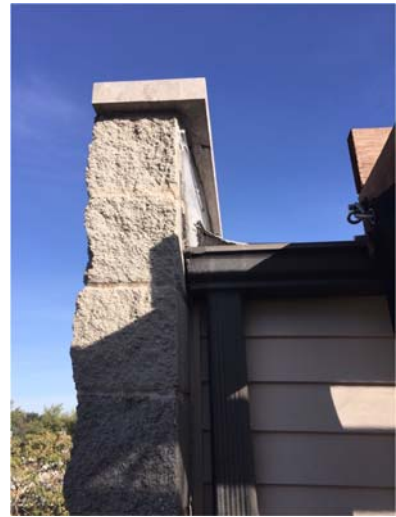
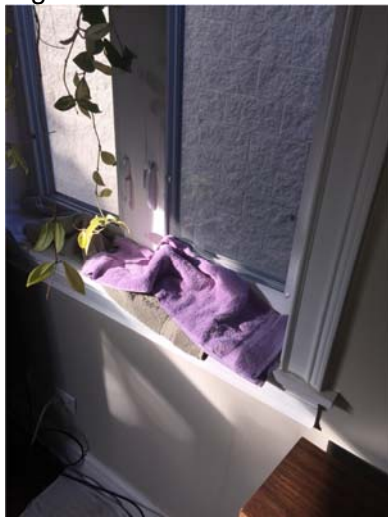
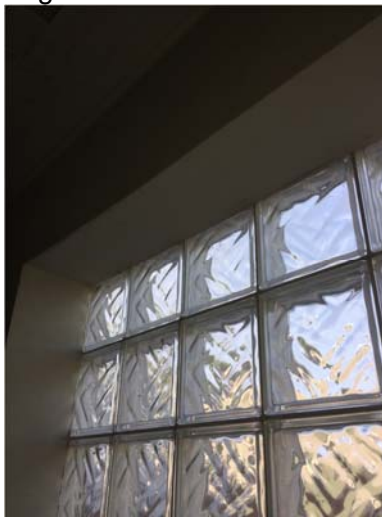
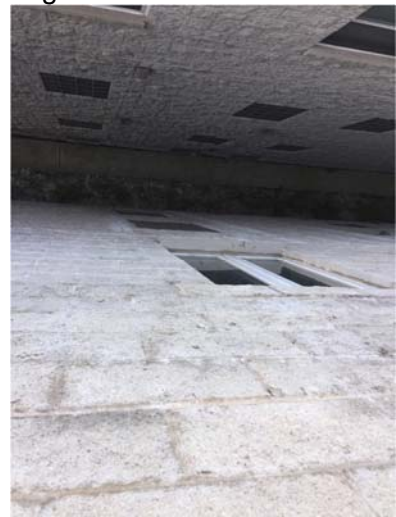
ESI inspected the condition of the structure at the time of the site inspection. The following is a summary of some of ESI's observations (Figures 3 through 8):

- Water staining was evident at openings in the masonry including windows on the west face of the building and the rear entryway.
- There was no evidence of any flashing protruding from the walls at the location of the wall openings where water infiltration was occurring.
- There was no evidence of issues with the roofing membrane.

- Water infiltration is occurring at various locations of the structure, but particularly at window and door openings.
- The water infiltration is occurring because of deficiencies in the original construction of the building with the predominate issue being improper flashing at wall openings.

- This condition was not of recent origin and has been present since the building was constructed.
- ESI recommends that the owner retain a masonry contractor to make exploratory openings in the masonry where the water infiltration is occurring and install proper flashing. All cracks in the masonry and other deficiencies should be addressed at that time.

- The flashing detail shall be installed in a manner that allows for any infiltration water to flow out of the building and shall also contain proper end dams.

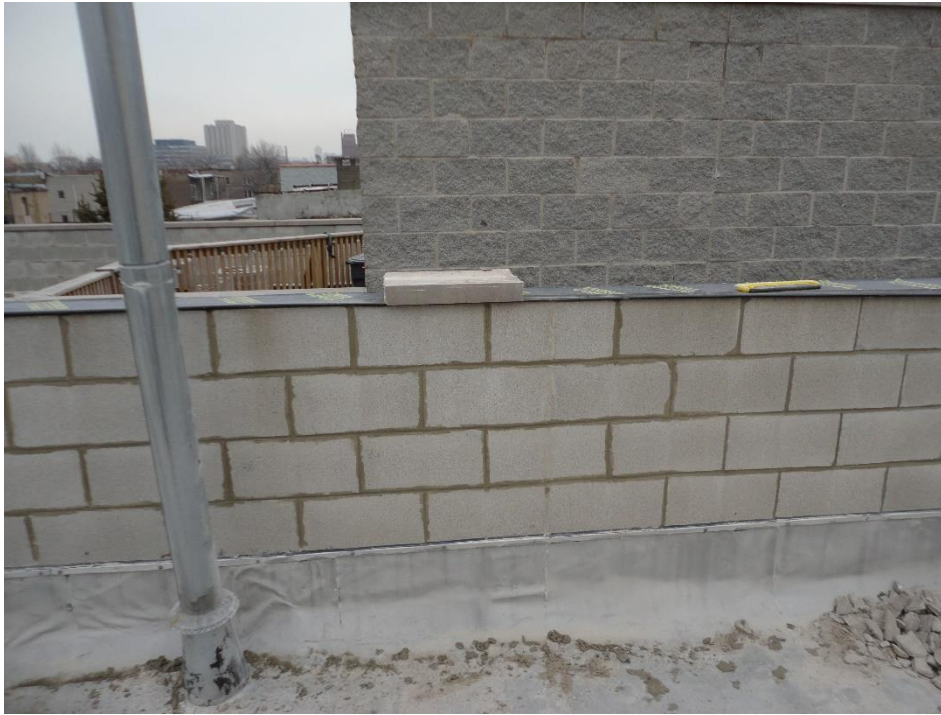
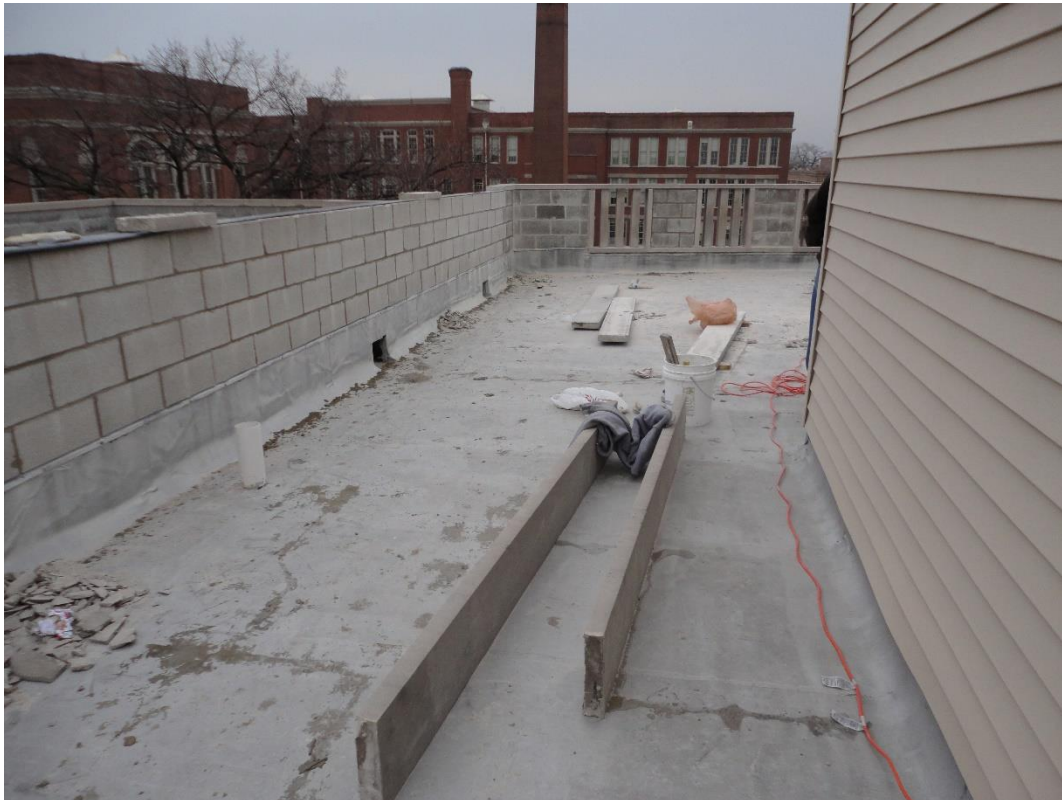
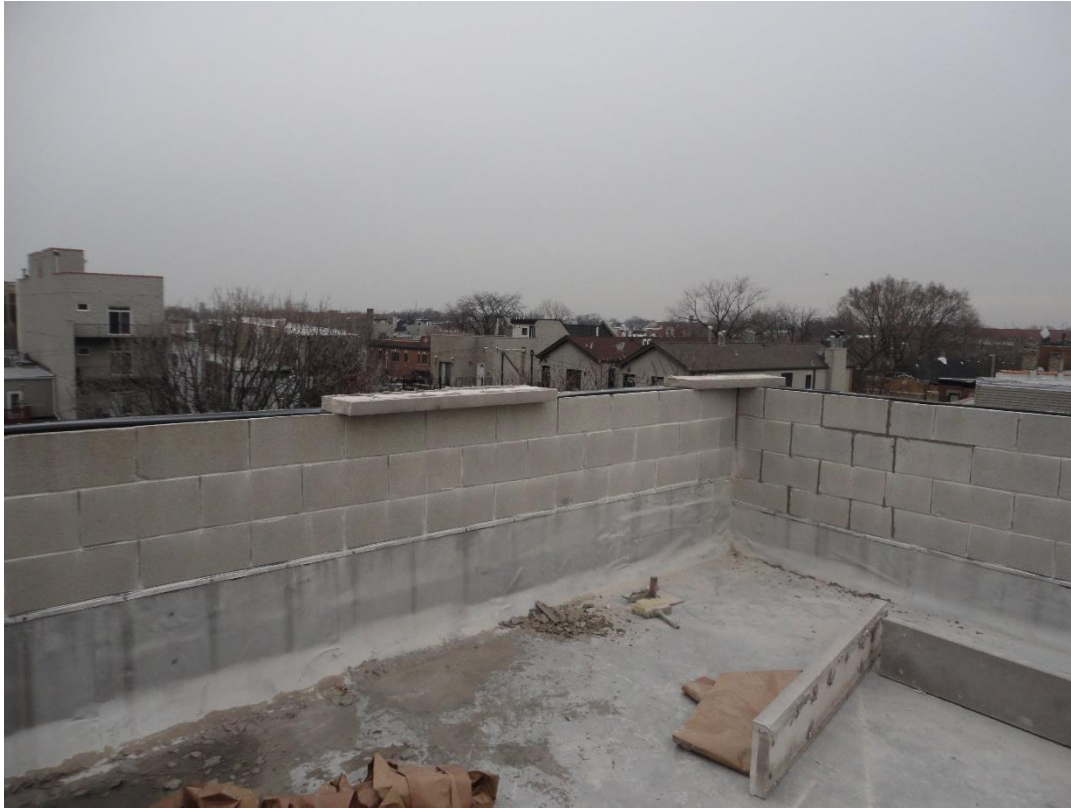
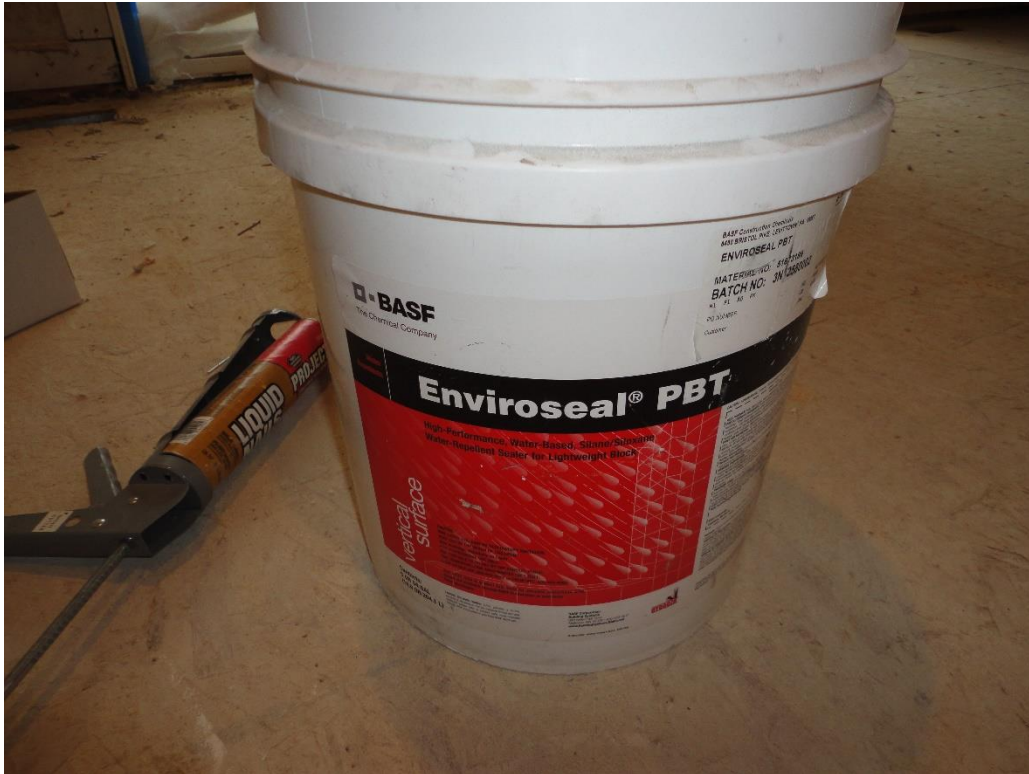
John, sorry to hear that your running into some issues at 2726 Cortez. We did remove and flashed all of the capstone and we also sealed the entire building. Attached you will find pictures of the work and what product we used to seal the block. We did numerous water tests

and had rains after the work was completed and we never had any water penetration. Jim Murrin

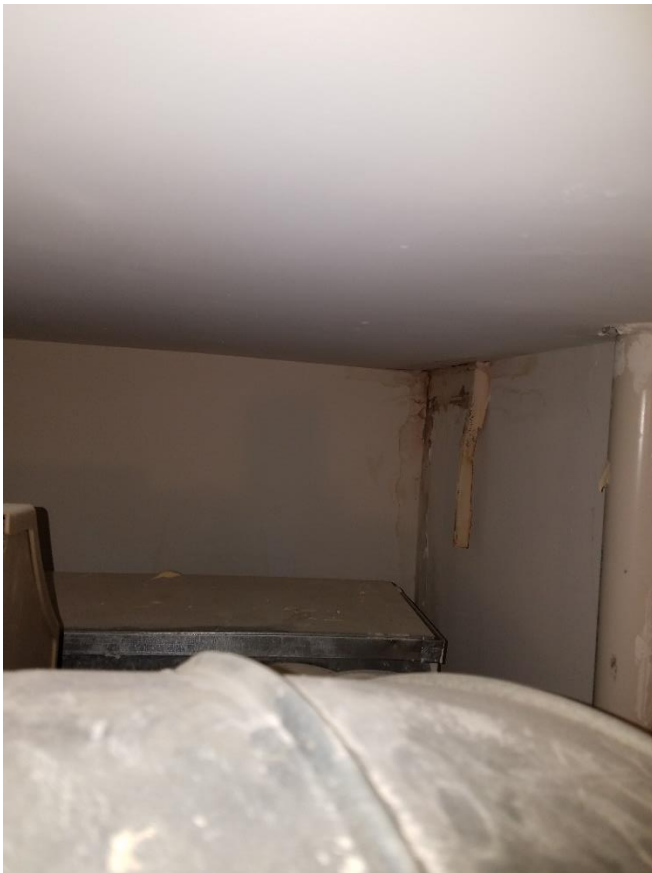
GONRING000243

There were leaks in above the utility room in the corner.

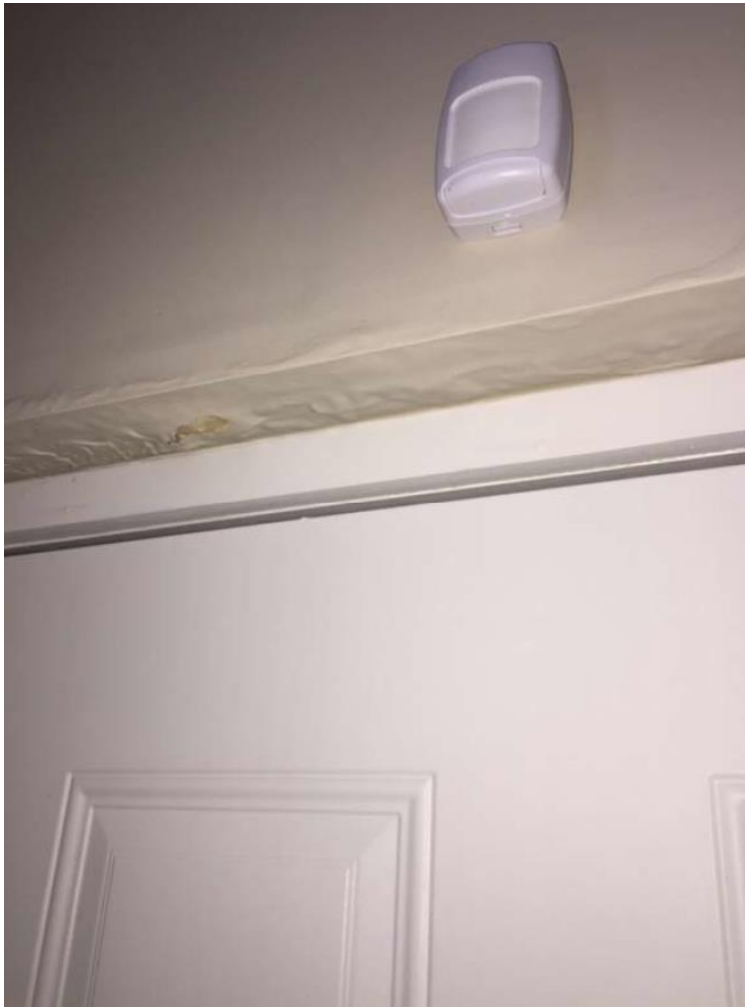
GONRING000244

At some point in 2016 there were leaks above back door. There is damage to drywall and paint.
